Device **TC27x**
Marking/Step **ES-CA, CA**
Package **see Data Sheet**

10214AERRA

This Errata Sheet describes the deviations from the current user documentation.

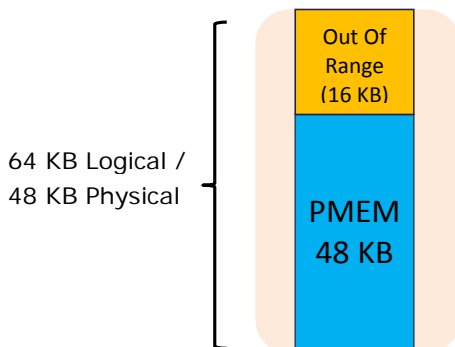
Figure 1 Example for Non-Power of Two PMEM

CPU_TC.125 Unexpected Address Error Alarms caused by Speculative Access to Out-of-range PMEM Areas

In TC27x, the following CPUs and memories are affected:

- CPU1 PMEM
- CPU2 PMEM

Note: The issue only affects non-power of two PMEM memories of a TC1.6P CPU as described above. Other CPU cores and memory configurations are not affected.

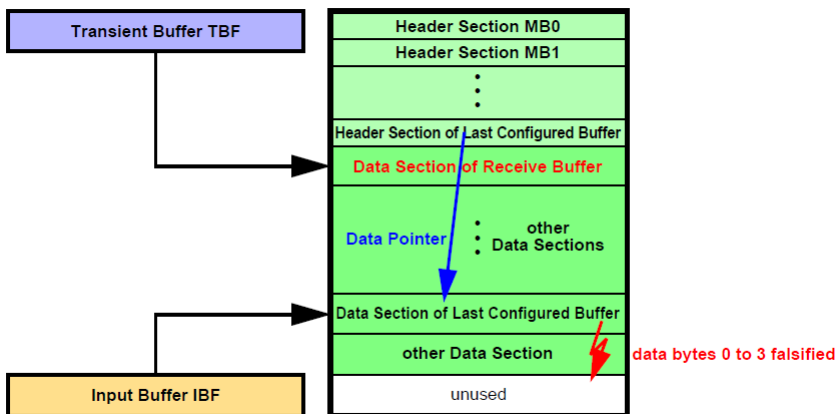
Figure 3 Message buffer transfer from IBF to Message RAM

b) Message buffer transfer from IBF to Message RAM

After the Data Section of the selected message buffer in the Message RAM has been written, one additional write access overwrites the following word in the Message RAM which might be the first word of the next Data Section.

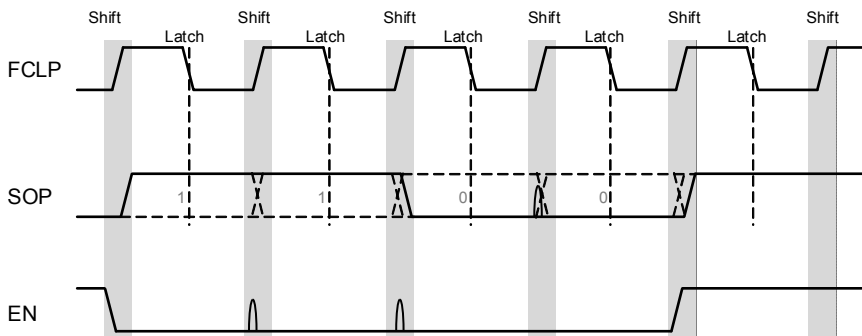
Figure 5 Theoretical Example for MSC Spike Scenario

The ABRA block of the MSC generates spikes in the serial output data (SO) and enable (EN0 to EN3) signals, that under some worst case conditions might become visible at the output of the corresponding pins.

The spikes would appear as shown in **Figure 5**, within the normal signal transition timing intervals, as defined with the data sheet timings t44 (SOPx output delay) and t45 (ENx output delay). The spikes would not cause violation of the timings.

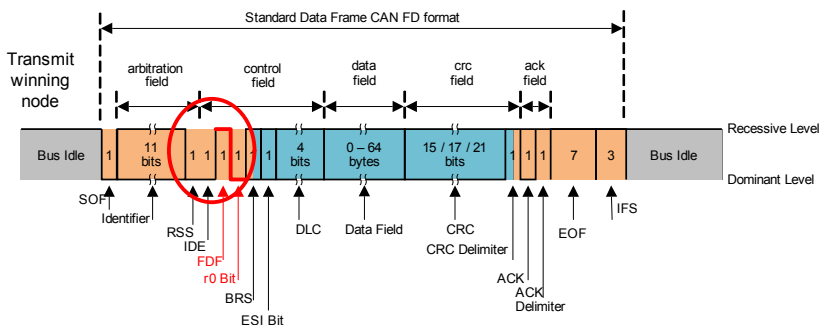
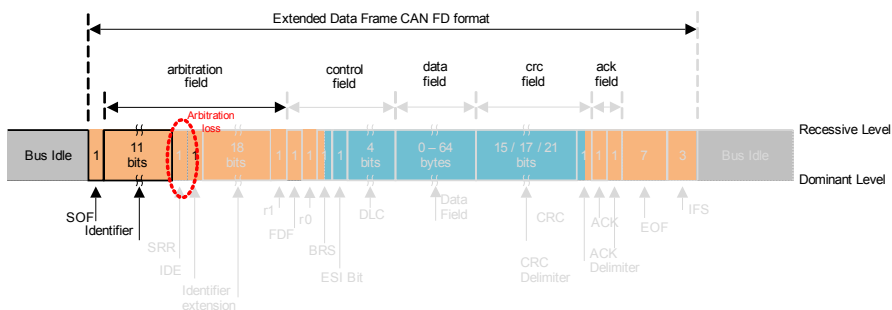
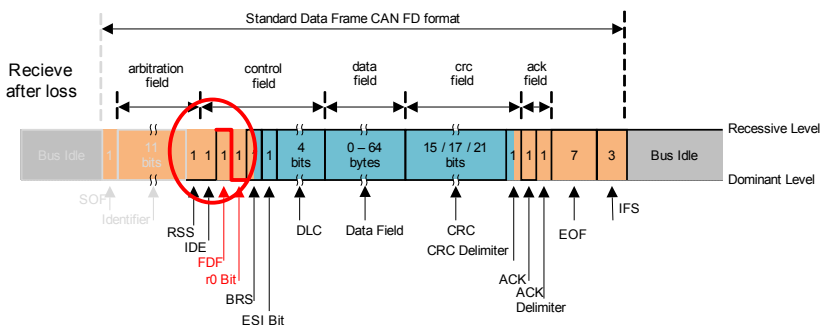
The device is producing more error frames within a network than a device with a hardsync at the FDF bit.

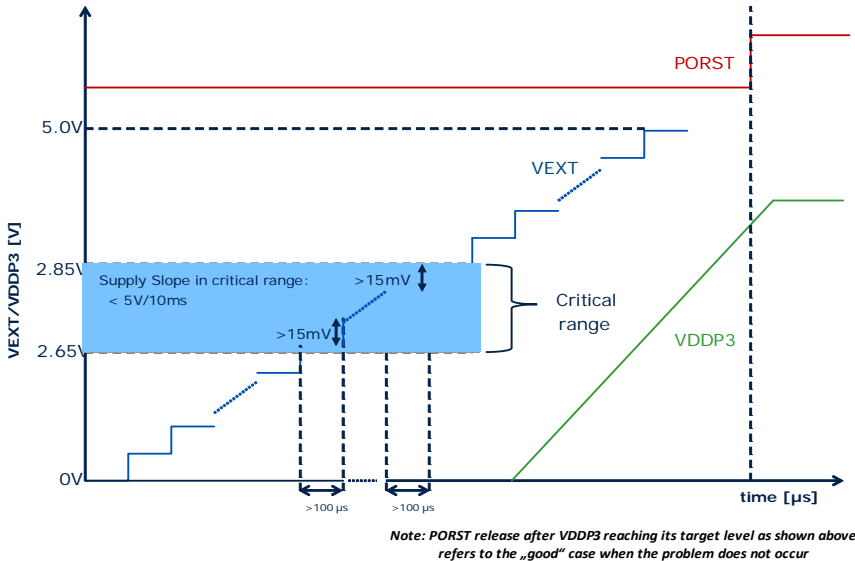
Figure 9 EVR Supply Voltage VEXT Ramp-up - Critical Range

- The fail behavior is observed only if the internal EVR33 regulator is used.
- The fail behavior is not observed together with TLF35584 regulator (owing to fast ramp-up slopes).

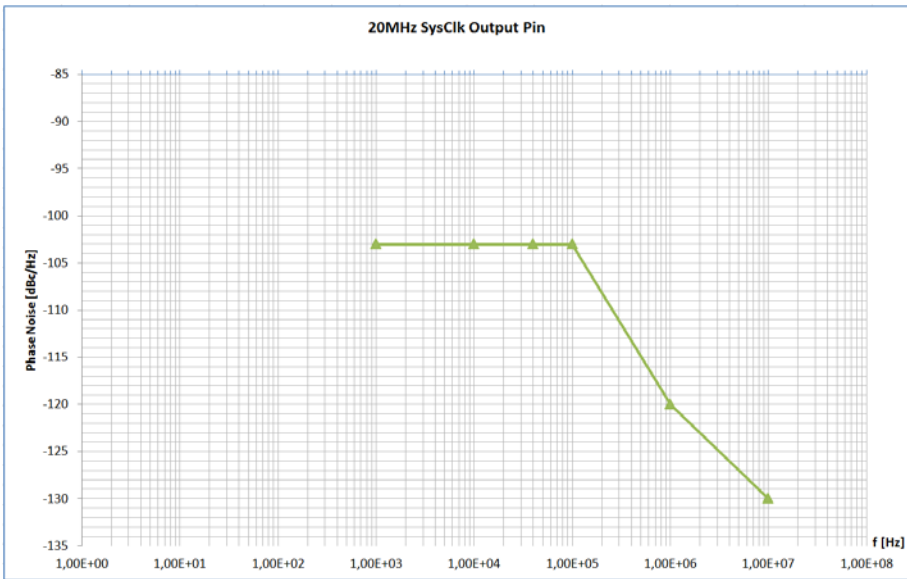
Figure 12 Phase Noise Density on SysClk Output Pin

Consistently, measurements on the HSSL/HSCT communication channel using the SysClk signal with I_{PN} from above show that the ultimate target of $BER_{20} = 10^{-12}$ is met. In such a measurement setup, both the master and the slave are microcontrollers of the AURIX™ family.

The diagram below shows the phase noise density on the SysClk pin when no application pattern but only the HSSL/HSCT subsystem is running:

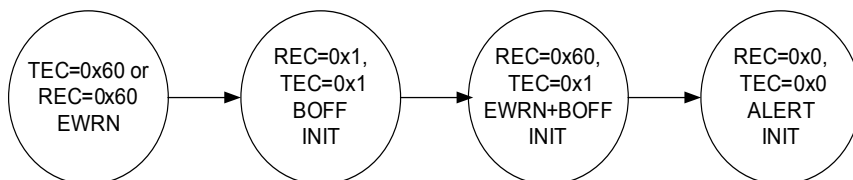
Figure 14 Alert Interrupt Behavior in case of Bus-Off

MultiCAN_AI.H007 Alert Interrupt Behavior in case of Bus-Off

The MultiCAN module shows the following behavior in case of a bus-off status:

When the threshold for error warning (EWRN) is reached (default value of Error Warning Level EWRN = 0x60), then the EWRN interrupt is issued. The bus-off (BOFF) status is reached if TEC > 255 according to CAN specification, changing the MultiCAN module with REC and TEC to the same value 0x1, setting the INIT bit to 1_B, and issuing the BOFF interrupt. The bus-off recovery phase starts automatically. Every time an idle time is seen, REC is incremented. If REC = 0x60, a combined status EWRN+BOFF is reached. The corresponding interrupt can also be seen as a pre-warning interrupt, that the bus-off recovery phase will be finished soon. When the bus-off recovery phase has finished (128 times idle time have been seen on the bus), EWRN and BOFF are cleared, the ALERT interrupt bit is set and the INIT bit is still set.

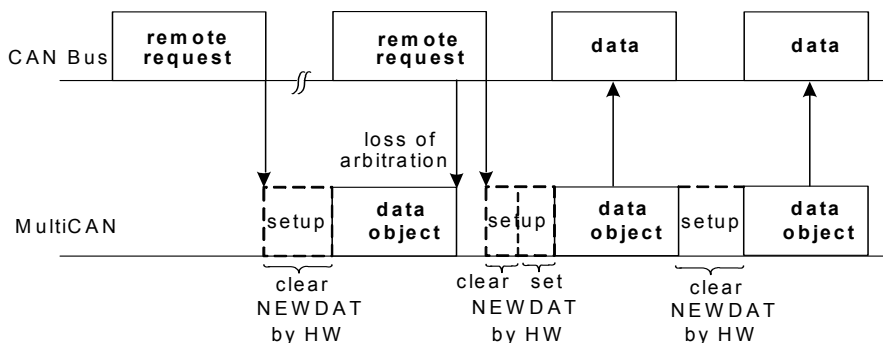
Figure 15 Loss of Arbitration

When the appropriate message object (data frame) triggered by the first remote frame wins the arbitration, it will be sent out and $NEWDAT$ is not reset. This leads to an additional data frame, that will be sent by this message object (clearing $NEWDAT$).

There will, however, not be more data frames than there are corresponding remote requests.

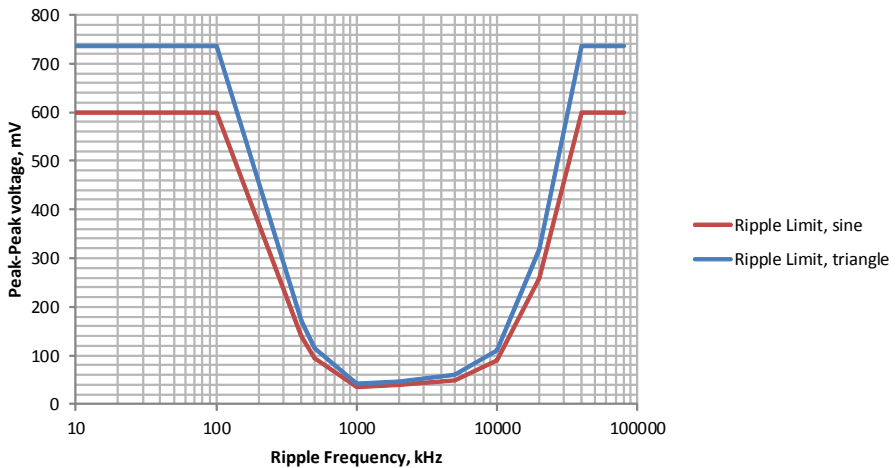
Figure 16 Ripple Voltage vs. Frequency Characteristic

The internal back-up clock is sensitive to specific power supply voltage disturbance/ripple caused by a voltage ripple intrinsic to DC-DC converters. Specific conditions such as insufficient filtering of the ripple may lead to improper behavior of the start-up scheme of the back-up clock, and thus stuck-at state during the start-up of the microcontroller until this condition is removed.

The acceptable voltage vs. frequency characteristic is portrayed below on the chart:

The diagram reflects acceptable ripple level during the cold start of the microcontroller at the respective VDDP3/VEXT/VEVRSB supply of the PMS subsystem, depending on the device and package type, as shown in the following table.

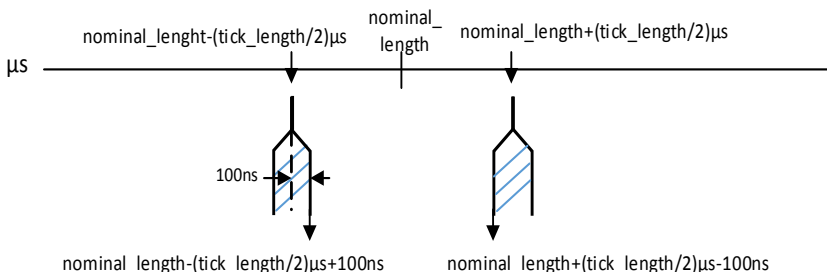
Figure 17 SENT Standard Tolerance

The length of a nibble in the SENT protocol determines the value of this nibble. For each value this length can vary, but it has to be at least inside a given range. This range is given by the SENT standard.

- The lower border is $\text{nominal_value} - (\text{tick_length}/2) \mu\text{s} + 100 \text{ ns}$
- The upper border is $\text{nominal_value} + (\text{tick_length}/2) \mu\text{s} - 100 \text{ ns}$.

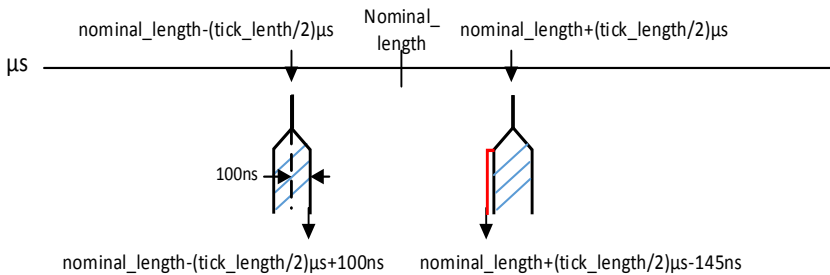
Figure 18 SENT Tolerance of this Design Step

In this design step the range is delimited as follows:

- The lower border is $\text{nominal_value} - (\text{tick_length}/2) \mu\text{s} + 100 \text{ ns}$
- The upper border is $\text{nominal_value} + (\text{tick_length}/2) \mu\text{s} - 145 \text{ ns}$.

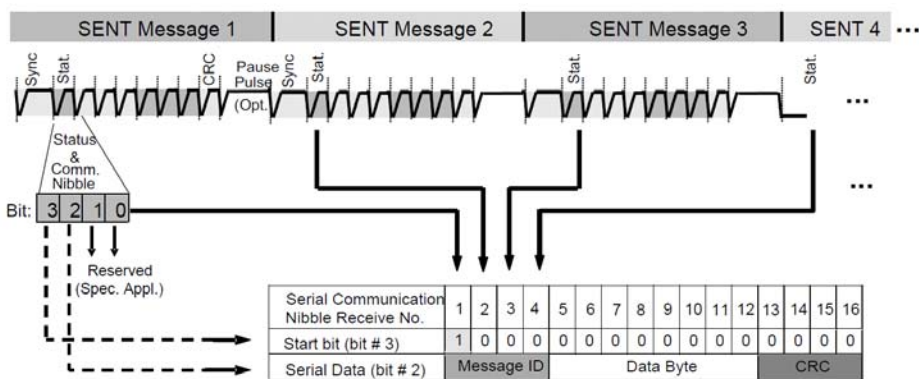
Figure 19 Short Serial Message, Serial Data Encoding over 16

Figure 19 shows a corrected version of this figure.

One serial message is composed of 16 SENT consecutive error-free messages.
