Device TC38x
Marking/Step (E)ES-AD, AD
Package see Data Sheet

No. 075/20

This Errata Sheet describes the deviations from the current user documentation.

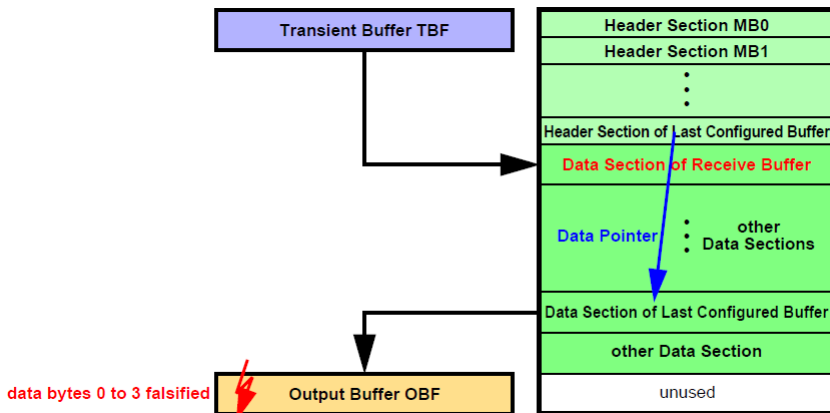
Figure 1 Message buffer transfer from Message RAM to OBF

When the message buffer has its payload configured to maximum length (PLC = 127), the OBF word on address 00h (payload data bytes 0 to 3) is overwritten with unexpected data at the end of the transfer.

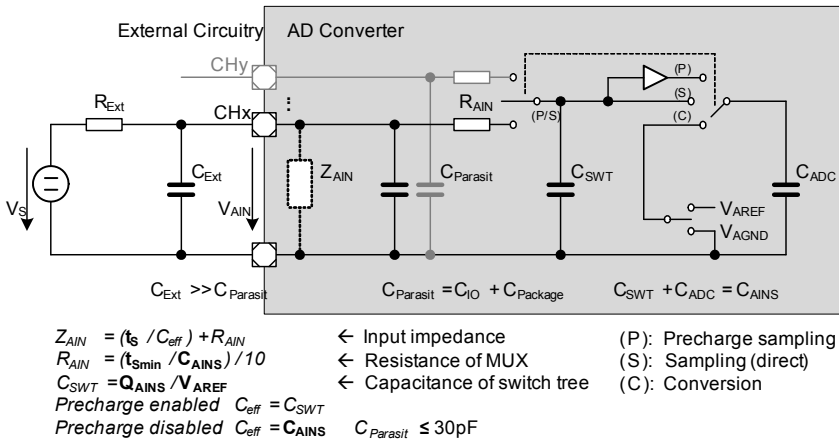
Figure 8 Equivalent Circuitry for Analog Inputs

Figure “Equivalent Circuitry for Analog Inputs” will be modified in future revisions of the Data Sheet, including the term $C_{Parasit} \leq 30$ pF, as shown in the following figure:

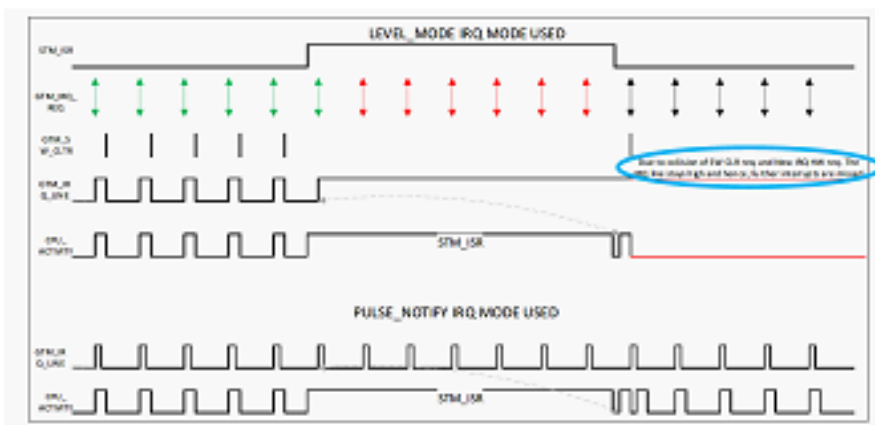
Figure 9 Interrupt Level vs. Pulse-Notify mode - Corner Case Example

Hence, in Level Mode, in some scenarios where another interrupt request is generated by GTM while the ISR handle also requests a SW clear, then, as the interrupt event is dominant over the clear event (for simultaneous interrupt and clear events), GTM_IRQ_XXX is not cleared and remains high. As a consequence, the IR observes no transition on GTM_IRQ_XX. Thus, any forthcoming interrupt events in this scenario are lost as there is no chance to release the CPU IRQ when a collision happens as shown in Figure below.

If Pulse-Notify mode is selected, every internal trigger will be forwarded to the IR, irrespective of the time of occurrence and the clear event, as the pulse-notify leads to set and reset of GTM_IRQ_XXX as compared to only setting of the GTM_IRQ_XXX line in Level mode.
