PureThermal OpenMV Hardware Errata

June 14, 2022 - Version 1.0

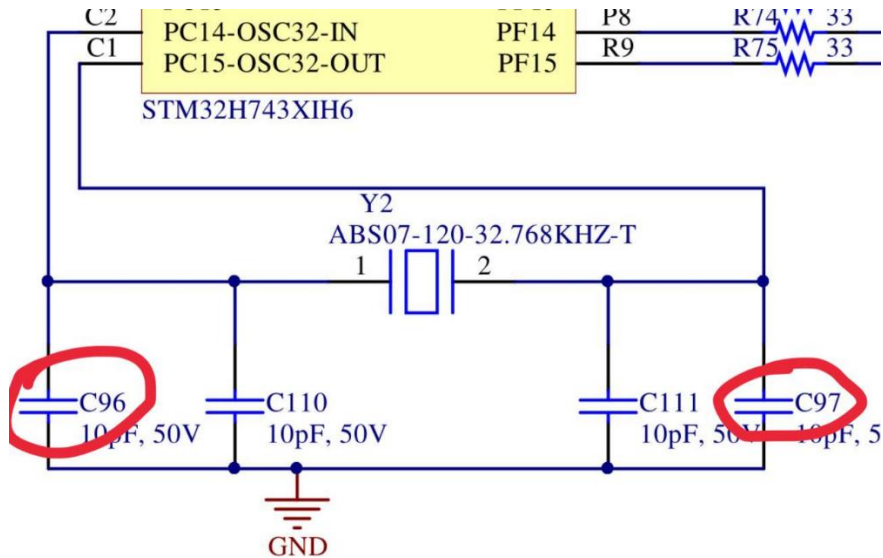
The load capacitance on the Y2 crystal is too high. Removing C96 and C97 can restore functionality to the RTC, but results may vary. These capacitors are already removed on some boards.

Figure 3: C96 and C97 are circled in this schematic view.

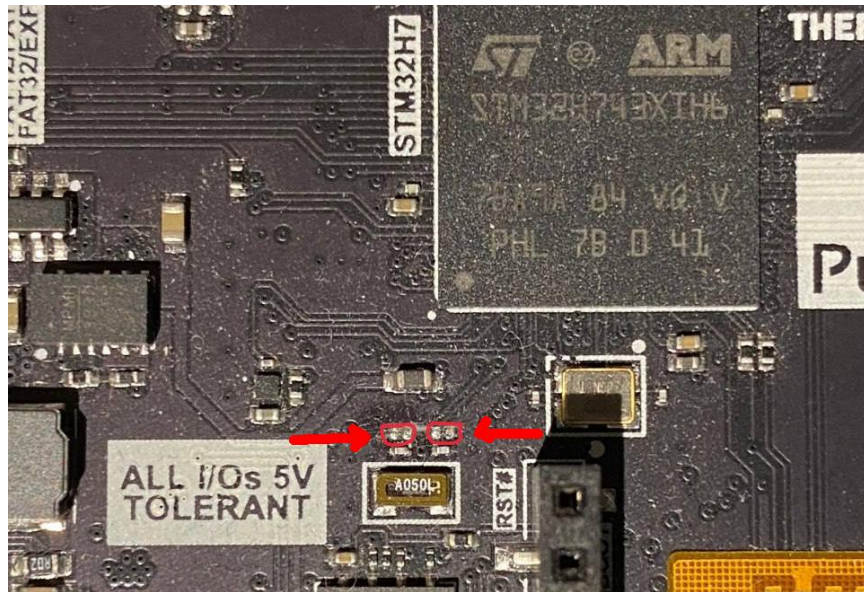
Figure 4: C96 and C97 are located adjacent to the STM32 package as shown.
