## PIC18(L)F24/25K42 Silicon Errata and Data Sheet Clarification

The PIC18(L)F24/25K42 devices that you have received conform functionally to the current Device Data Sheet (DS40001869E), except for the anomalies described in this document.

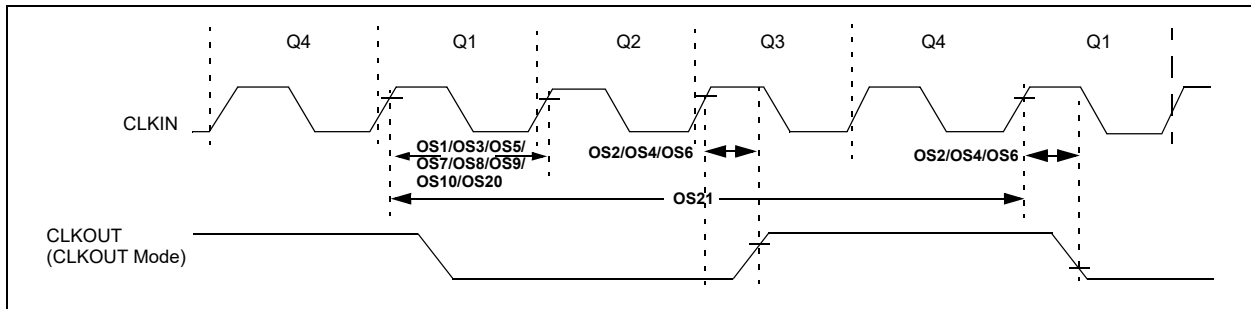
Figure 44-5 Clock Timing

Figure 44-5 incorrectly shows the location of parameters OS1, OS2, OS3, OS4, OS5, OS6, OS7, OS8, OS9, OS10, OS20 and OS21. The correct location for the above-mentioned parameters is depicted in the following figure.
