STM32L05xxx/L06xxx device errata

This document applies to the part numbers of STM32L05xxx/L06xxx devices and the device variants as stated in this page.

It gives a summary and a description of the device errata, with respect to the device datasheet and reference manual RM0367/RM0376/RM0377.

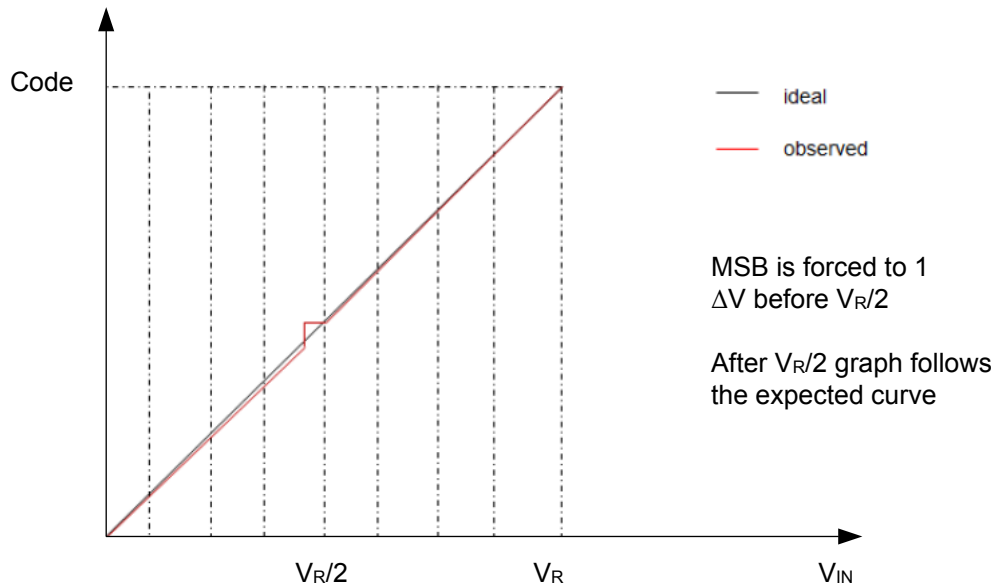
Figure 1. Data transfer curve

When V_{REF+} is lower than V_{DDA} , and only in this case, the data MSB is forced to 1 just before V_{IN} reaches $V_{REF+}/2$. As a result, the data transfer curve shows a discrepancy around $V_{REF+}/2$ (see [Figure 1](#)).

1. The transfer curve behaves as expected when V_{IN} is strictly lower or higher than $V_{REF+}/2$.

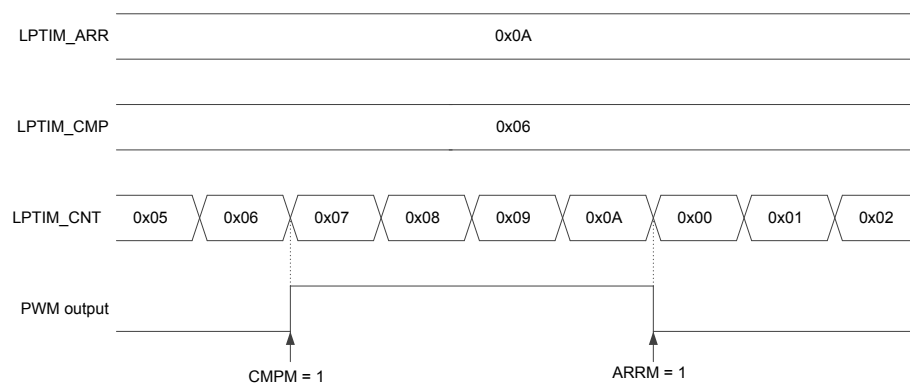
Consequently, it is not possible to generate PWM with a duty cycle of 0% or 100%.

The following waveform gives the example of PWM output mode and the effect of the delay:

Set the compare value to the desired value minus 1. For instance in order to generate a compare match when LPTM_CNT = 0x08, set the compare value to 0x07.

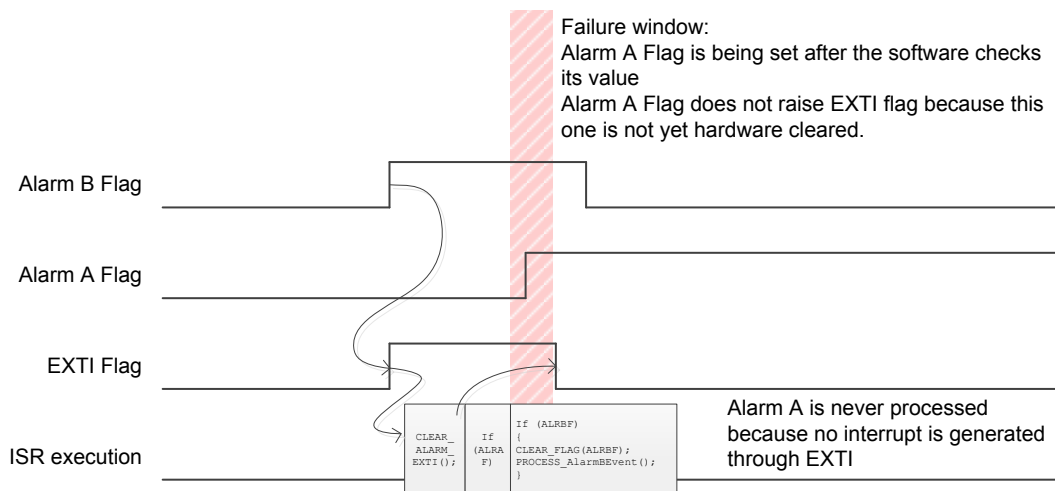
Figure 2. Masked RTC interrupt

The following code example and figure illustrate the failure mechanism: The Alarm A event is lost (fails to generate interrupt) as it occurs in the failure window, that is, after checking the Alarm A event flag but before the effective clear of the EXTI interrupt flag by hardware. The effective clear of the EXTI interrupt flag is delayed with respect to the software instruction to clear it.

In the interrupt service routine, apply three consecutive event flag checks - source one, source two, and source one again, as in the following code example:
