Device TC37x
Marking/Step (E)ES-AA, AA
Package see Data Sheet

10375AERRA

This Errata Sheet describes the deviations from the current user documentation.

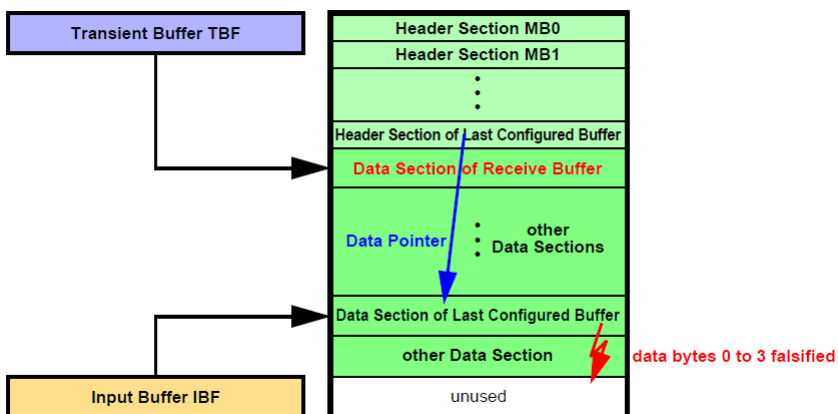
Figure 2 Message buffer transfer from IBF to Message RAM

After the Data Section of the selected message buffer in the Message RAM has been written, one additional write access overwrites the following word in the Message RAM which might be the first word of the next Data Section.

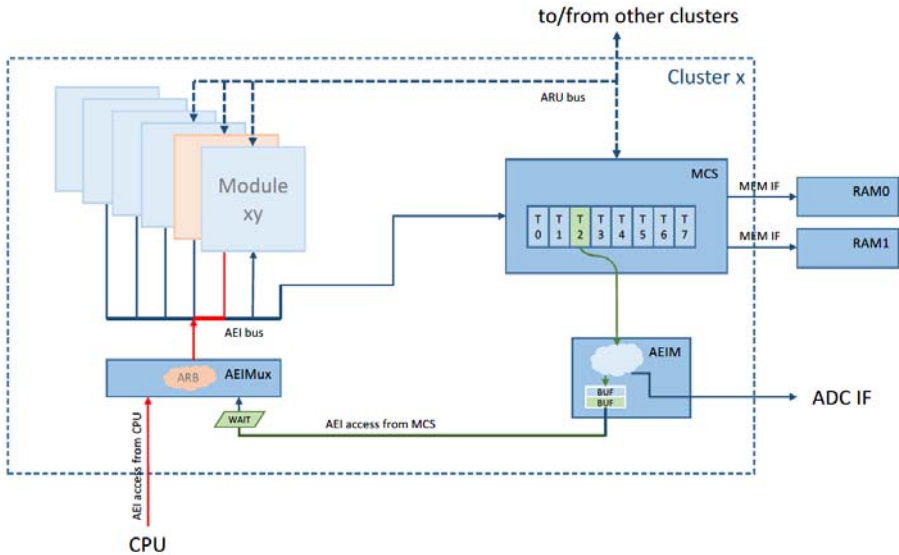
Figure 5 MCS AEI master access path

Figure 5 shows an uncritical traffic situation. Here an access of a MCS thread to the AEI bus (green access path) is temporarily delayed due to an ongoing AEI bus access from the CPU (red access path). The MCS access to the AEI bus will be safely buffered at the AEIM (green buffer). As soon as the CPU access to the AEI bus completes, the buffered AEI bus access from MCS will be executed.

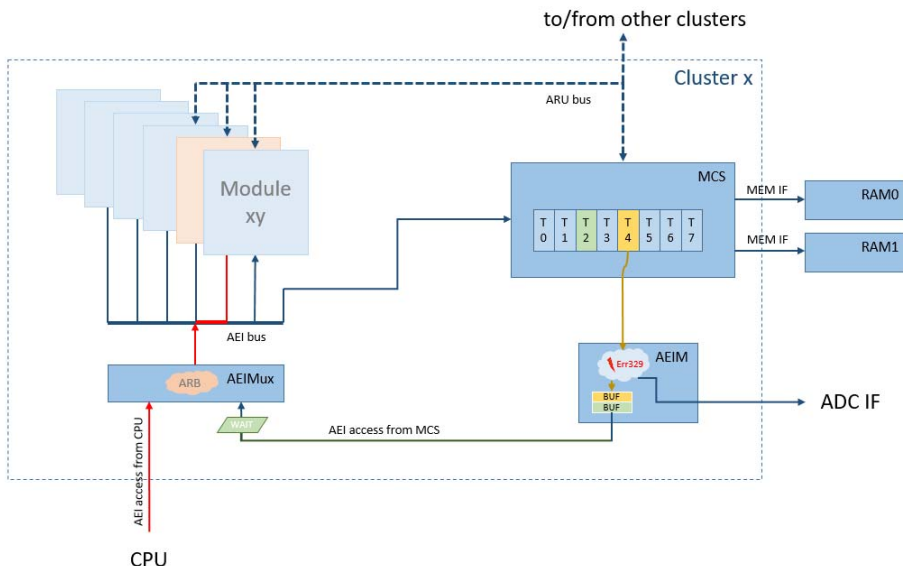
Figure 6 Critical MCS AEI master scenario

In [Figure 6](#), a potential risk for the occurrence of problem GTM_AI.329 is illustrated. Here the first buffer of the AEIM (green) is still waiting for the access to the AEI bus while a second AEI bus access from MCS arrives at the AEIM (yellow access path). Under certain, but for the user unpredictable timing conditions, this second AEI bus access arriving at the AEIM can trigger the misbehavior described in problem GTM_AI.329.

The workarounds described in the following section will ensure that not more than one AEIM buffer will be filled and therefore the occurrence of problem GTM_AI.329 is avoided. All workarounds have been tested and proven correct.

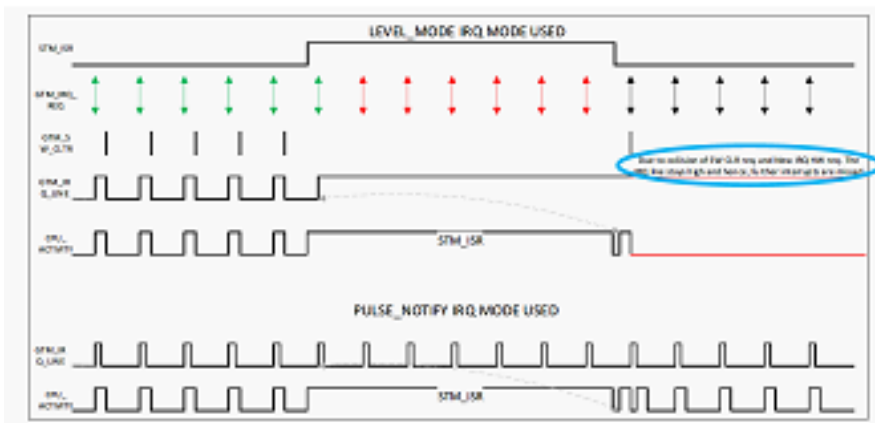
Figure 8 Interrupt Level vs. Pulse-Notify mode - Corner Case Example

Hence, in Level Mode, in some scenarios where another interrupt request is generated by GTM while the ISR handle also requests a SW clear, then, as the interrupt event is dominant over the clear event (for simultaneous interrupt and clear events), GTM_IRQ_XXX is not cleared and remains high. As a consequence, the IR observes no transition on GTM_IRQ_XX. Thus, any forthcoming interrupt events in this scenario are lost as there is no chance to release the CPU IRQ when a collision happens as shown in Figure below.

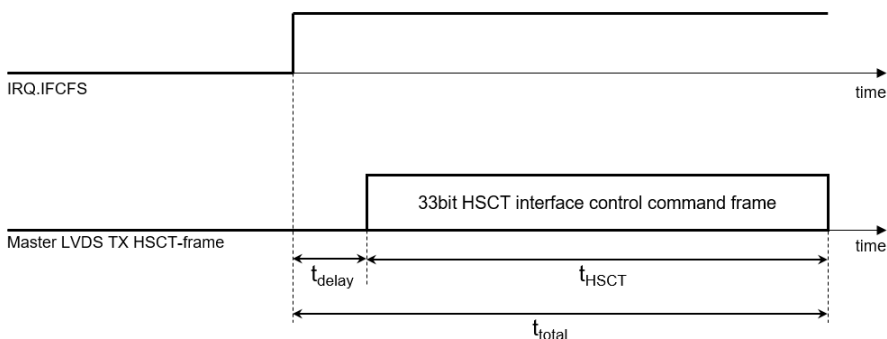
Figure 9 Timing of LVDS TX interface command sending in relation to IRQ.IFCFS

the user might falsely assume that also the actual sending on the LVDS TX port has already occurred once the IRQ.IFCFS flag is set, which is not true.

Instead the timing shown in [Figure 9](#) applies.

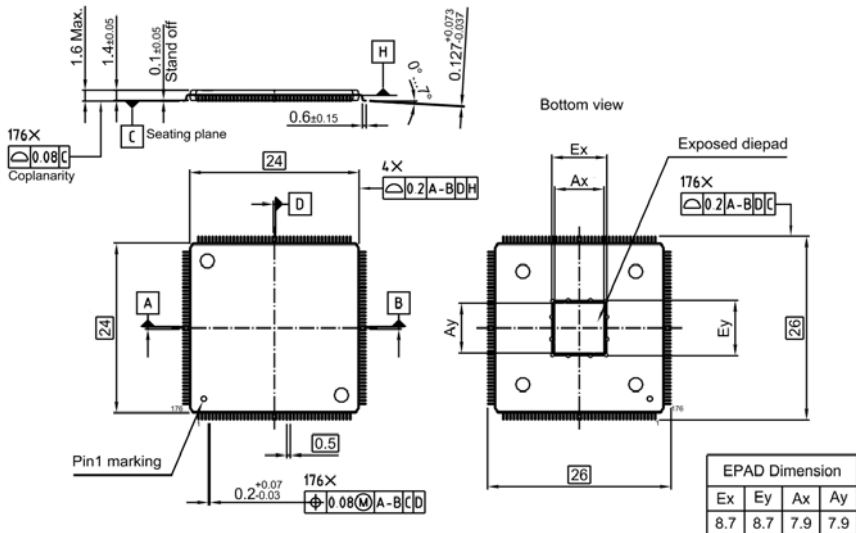
Figure 10 Package Outlines LQFP-176 for TC37x

Note: For the exposed diepad of the LQFP-176 package of the TC37x, structural corner protrusions have to be considered for purposes of system design and integration with a maximum boundary of 9.4 mm.

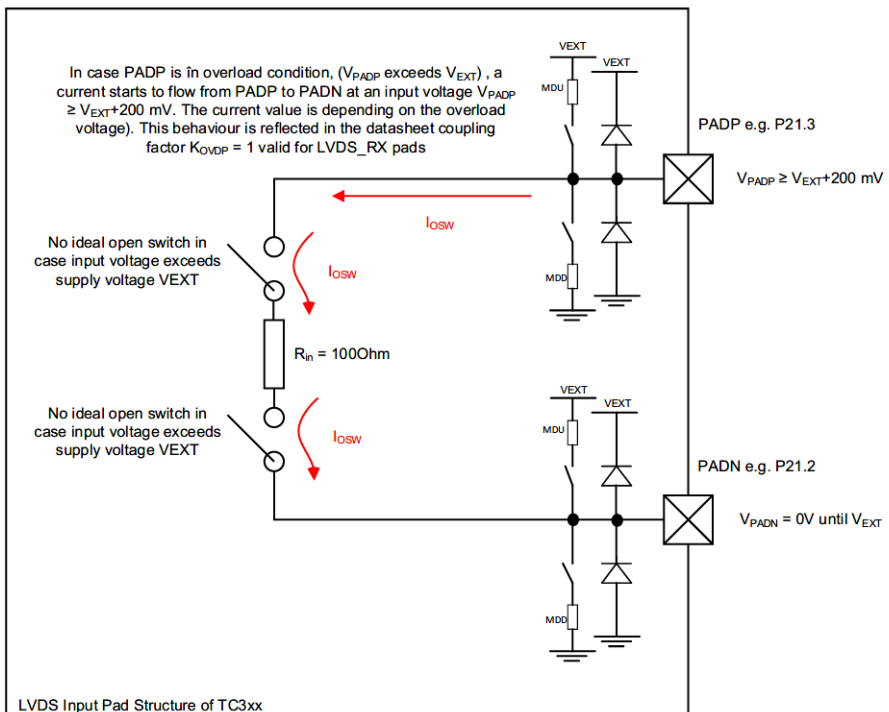
Figure 11 Positive overload on P-pad of a LVDS RX pin pair (both used as inputs)

The overload current I_{OSW} through the non-ideal open switch significantly increases when $V_{PADP} \geq V_{EXT} + 200\text{ mV}$.

Note: In general, the effect will also occur if the N-pad is used as output, or for a negative overload condition on either the P-pad or the N-pad.
