## STM32L433xx/443xx device errata

This document applies to the part numbers of STM32L433xx/443xx devices and the device variants as stated in this page. It gives a summary and a description of the device errata, with respect to the device datasheet and reference manual RM0394. Deviation of the real device behavior from the intended device behavior is considered to be a device limitation. Deviation of the description in the reference manual or the datasheet from the intended device behavior is considered to be a documentation erratum. The term “errata” applies both to limitations and documentation errata.

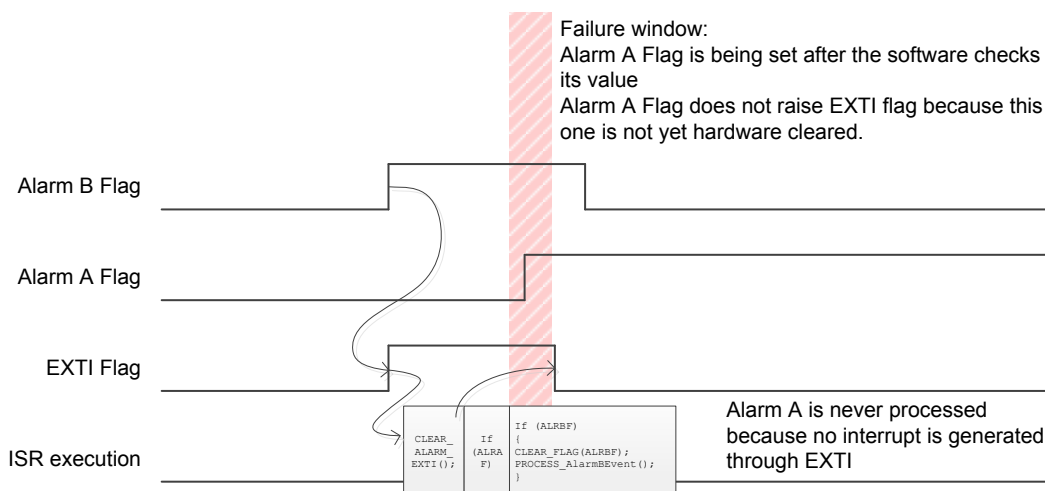
Figure 1. Masked RTC interrupt

The following code example and figure illustrate the failure mechanism: The Alarm A event is lost (fails to generate interrupt) as it occurs in the failure window, that is, after checking the Alarm A event flag but before the effective clear of the EXTI interrupt flag by hardware. The effective clear of the EXTI interrupt flag is delayed with respect to the software instruction to clear it.
