This errata sheet provides updated information about known device issues affecting Stratix® IV GX devices.

Production Device Issues for Stratix IV GX Devices

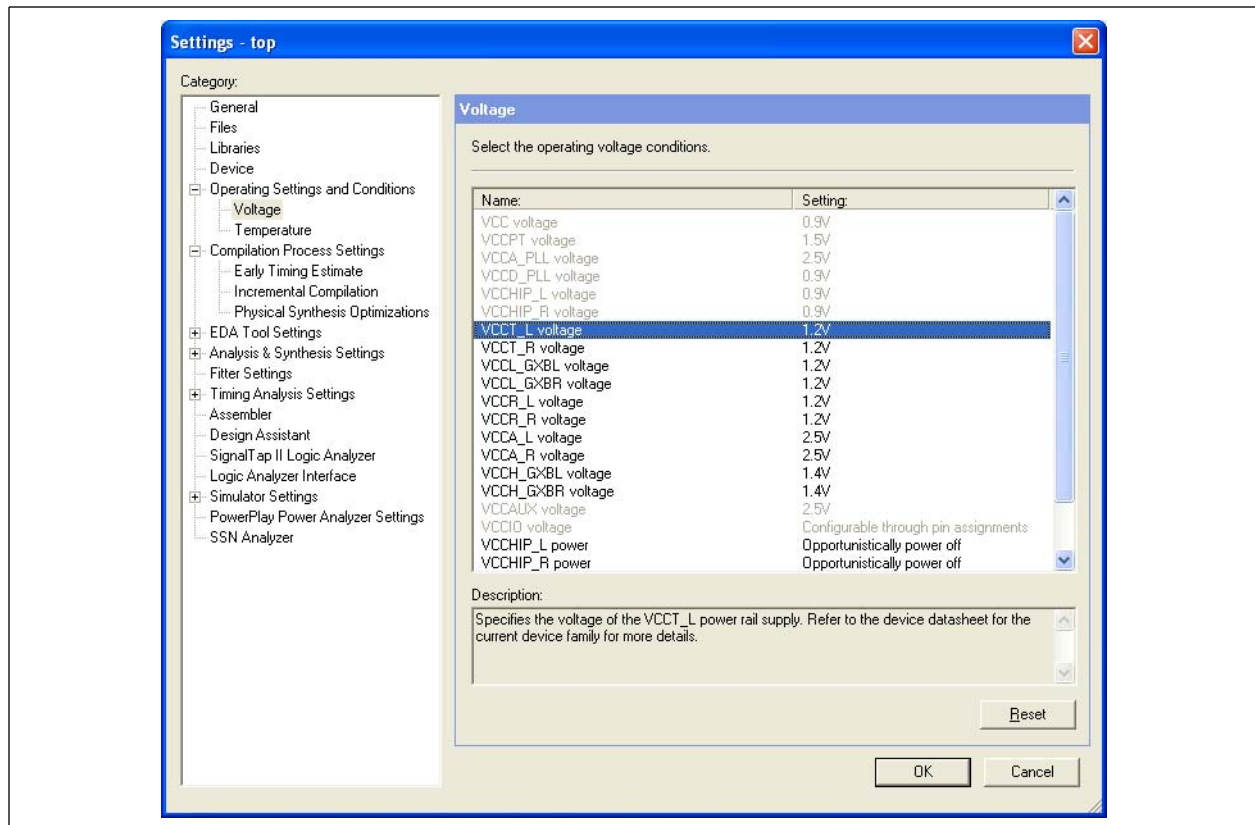
Figure 9. Setting Voltage Levels

- **Category 2:** The configured xN line data rate is greater than the maximum data rate supported by 1.1 V, but less than or equal to that supported by the 1.2-V power supply level specified in [Table 2](#).

Action: In the Quartus II software, on the Assignments menu, click **Settings**. Click the "+" icon to expand **Operating Settings and Conditions** and select **Voltage**. Set the **VCCT_L/R**, **VCCL_GXBL/R**, and **VCCR_L/R** voltage settings from **1.1V** to **1.2V**, as shown in [Figure 9](#). Then recompile the project.

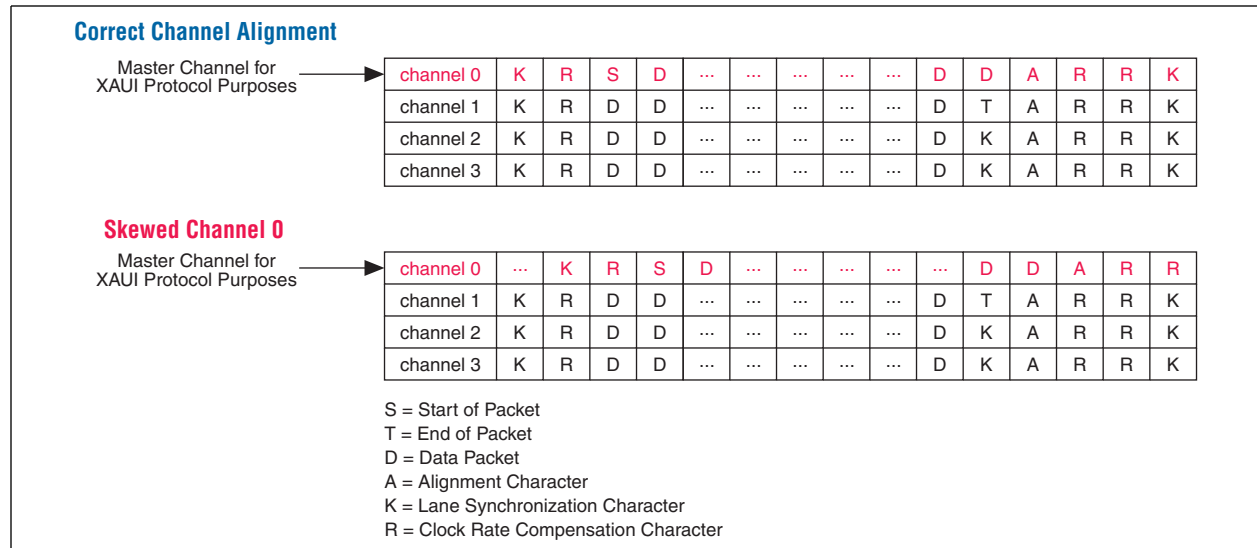
Figure 10. Rate Match FIFO Skew

In XAUI functional mode, the data out of the physical transceiver channel 0's Rate Match FIFO may be shifted by one byte with respect to the data of the other three channels. This shift causes incorrect idle ordered set conversion, resulting in incorrect received parallel data. The corrupted received parallel data caused by improper idle ordered set conversion or rate matcher corruption happens only during initialization or receiver channel reset (assertion of rx_analogreset or rx_digitalreset).

Figure 10 shows the channel skew.

Altera provides a soft IP solution and associated documentation, available for download at: www.altera.com/patches/xau-softip/xau-softip-fix-reva.zip

Integrate this soft IP into the XAUI receiver data path.
