ABSTRACT

This document describes the known exceptions to the functional specifications (advisories).

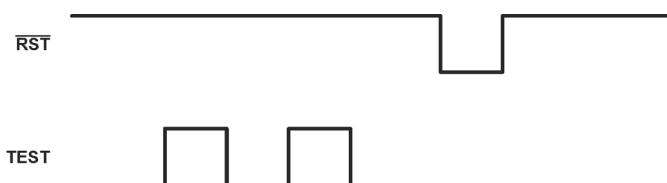
- Toggle the TEST pin twice when nRST is high and after 50us pull nRST low.

Note: This toggling of TEST pins is not subject to timing constraints. The appropriate level transitions on TEST pin, followed by a RST pulse after 50us, are sufficient to trigger an exit from BSL mode.
