Device TC37x
Marking/Step (E)ES-AA, AA
Package see Data Sheet

10375AERRA

This Errata Sheet describes the deviations from the current user documentation.

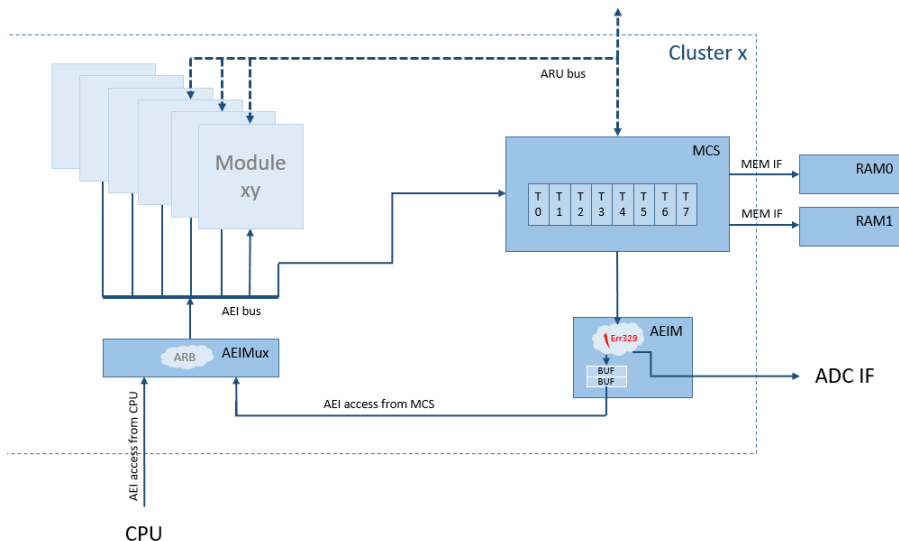
Figure 4 Cluster-internal AEI network

Problem GTM_AI.329 is related to a potential incorrect handling of MCS access requests to the AEI bus at the AEIM entry stage in case that one AEIM buffer is already filled. If in such a case a new access request from MCS enters the AEIM logic during a very specific time window (related to progress on the AEI bus), the AEIM logic might signalize incorrect parameters back to MCS that could result in incorrect data, the loss of data or a repetitive execution of MCS accesses to AEI.
