Product Change Notification
Software Release Notice

MultiConnect[®] rCell 100 Series Cellular Routers

mPower[™] Edge Intelligence mPower 5.2 Firmware Available

PCN 06022020-MTR-001

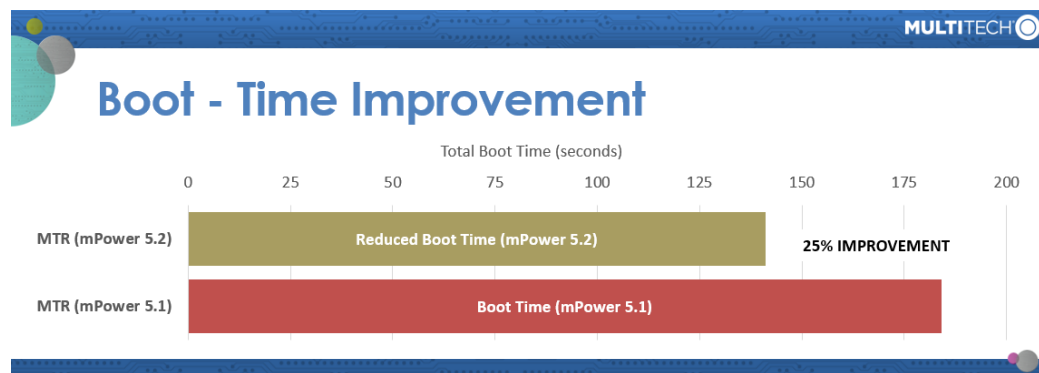
1. Reduced Boot Time Previous versions of mPower resulted in longer boot times. mPower 5.2 includes new features and optimization that decrease the device boot time up to 25% [GP-256, GP-360, GP-362, GP-363, GP-364]

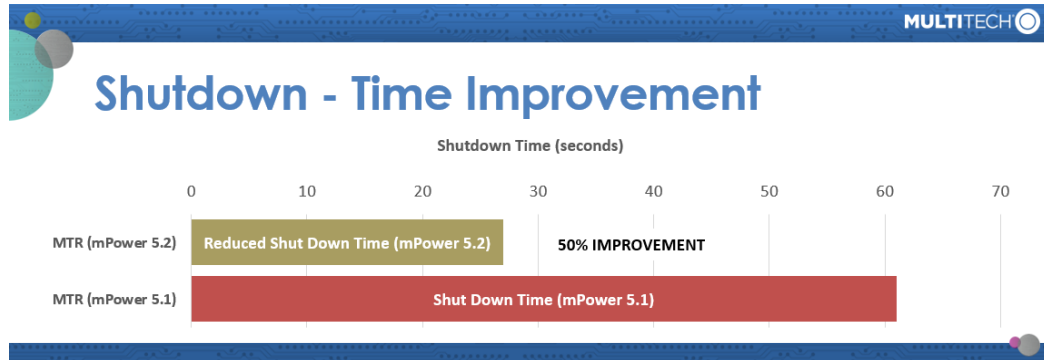
2. **Shutdown Time Optimization:** When restarting a device, the total time to reboot also includes shutdown time. Previous versions of mPower resulted in longer shutdown times. mPower 5.2 has been updated to reduce shutdown time. MTR mPower shutdown time has been shortened by 50%.

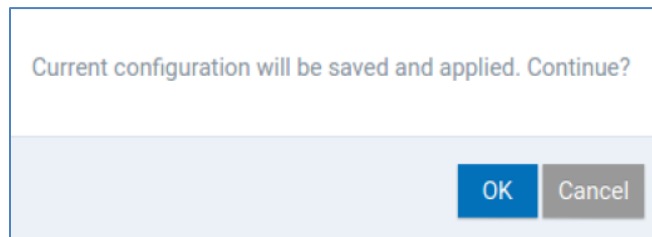
3. **Save and Apply Configuration Settings without Restarting:** Previous versions of mPower required a device reboot for most system configuration settings. mPower 5.2 has been updated to save and apply many configuration settings without the need to restart. In these cases, the user will be presented a “Save and Apply” button after making configuration settings. If “Cancel” is selected, changes are not saved. [GP-339]

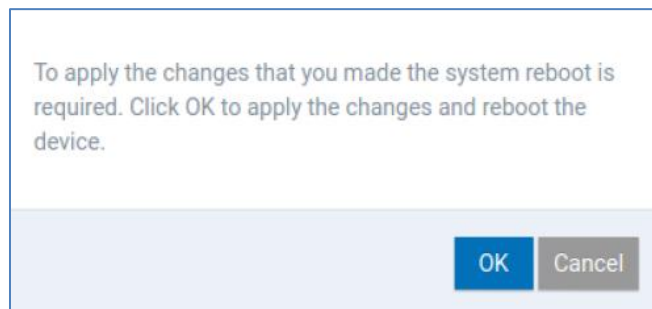
A limited number of system configuration setting changes will still require the device to be restarted. In these cases, the user will be presented with a “Save and Reboot” button after making configuration settings. If “Cancel” is selected, changes are not saved.
